Mechanical and Electrical Systems
Existing Conditions Narrative

Regional School District 13
Korn Elementary School
Durham, CT

Date: March 26, 2014

Prepared by:
Consulting Engineering Services, Inc.
811 Middle Street, Middletown, Connecticut 06457
CES PN 2013224.00

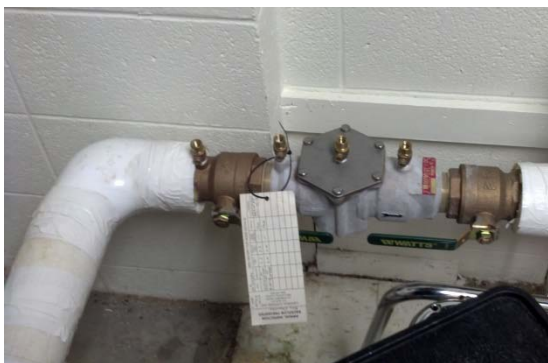
1. **Domestic Water:** The building is provided with a domestic water service that enters the building on the northeast corner. The service entrance incorporates an isolation valve, reduced pressure backflow preventer and water hammer arrestors. This service is supplied by a well water system. There are three wells located on the School campus. All three wells are piped to a domestic water pumping station located within a concrete vault near the High School. All wells are metered and manifolded together and discharge into a 15,000 gallon atmospheric tank. Outlet from the atmospheric tank is connected to a tri-plex water pump station. Pump discharges to a 5,000 gallon hydromatic tank. Both hydromatic tank and atmospheric tank bulkhead into the buried vault. System incorporates pump controls, well pump master control station and air compressor. The atmospheric tank has recently been relined. There are leaks developing at the hydro-tank where it penetrates the concrete vault. All components of the system have been installed to meet the requirements of the State of CT Department of Public Health for a central drinking water distribution system. This equipment is in good condition.

Existing Backflow Preventer

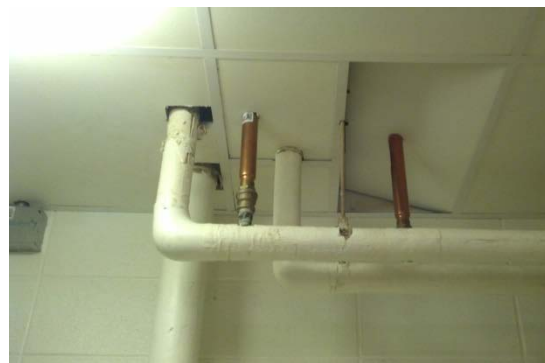
Existing Water Hammer Arrestors

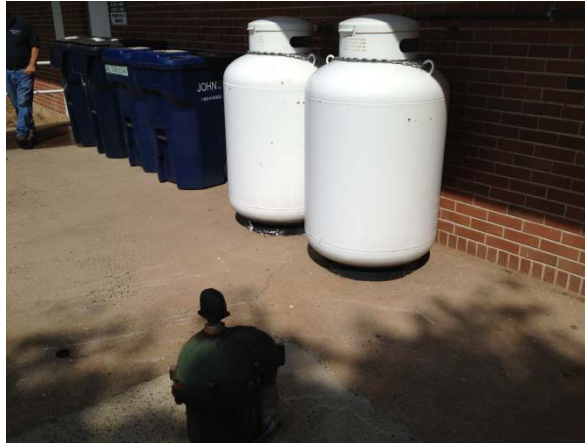
2. Propane Tanks: The building is currently served by two above ground propane tanks located on the south side of the building. The tanks have approximately 80 gallons of storage and their age is unknown. The propane tanks serve the kitchen and are in good condition.

Existing propane tanks

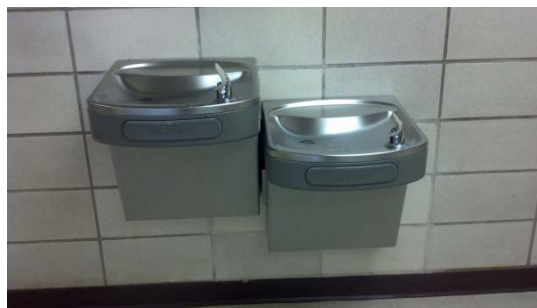
1. Water closets are wall mounted vitreous china with manual 1.6 GPF flush valves. The fixtures are in good condition and ADA compliant fixtures are provided.
2. Urinals are wall hung, vitreous china, with manual 1 GPF flush valves. The fixtures are in good condition and ADA compliant fixtures are provided.
3. Lavatories are wall hung vitreous china .5 GPM with single lever type faucets. ADA lavatories are provided with insulation wrap for exposed piping below fixture. The fixtures are in good condition and ADA compliant fixtures are provided.
4. Drinking fountains are wall mounted stainless steel water coolers. Some units are single bowl and some are bi-level double bowl units. Most units are in good condition and ADA compliant fixtures are provided.

Existing Electric Water Coolers

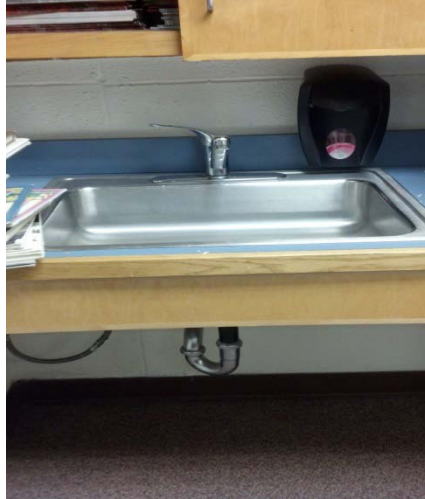
- Classroom sinks are stainless steel sinks with single lever faucets. These sinks are in good condition and are ADA compliant in some locations.

Existing ADA Sink

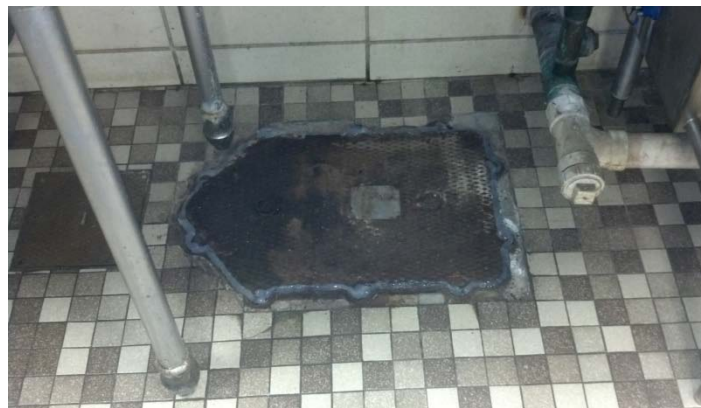
- Janitor sinks are floor mounted mop basins with two lever faucets. Faucets have integral vacuum breakers. Chemical shot feeders are provided in some custodial closets. These sinks are in good condition.
- The Kitchen has a point of use passive type grease interceptor recessed in the floor that serves the existing dishwasher. The grease interceptor cover has been silicone caulked to seal sewer gases. There are no grease interceptors at the existing three pot sink. If there is actual cooking being done and this is not a warming kitchen, a grease interceptor may be required on the three-bay sink. The actual size is based on the number of meals served per day. The silicone caulk on the existing grease interceptor indicates that the seal is compromised and should be replaced.

Existing Passive Grease Interceptor

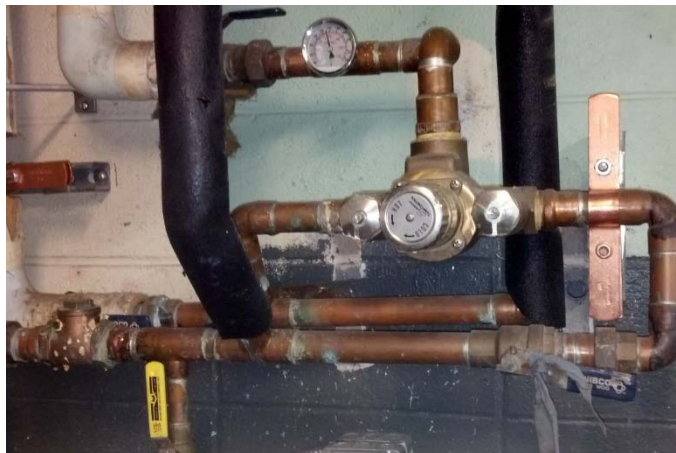
Existing Thermostatic Mixing Valve

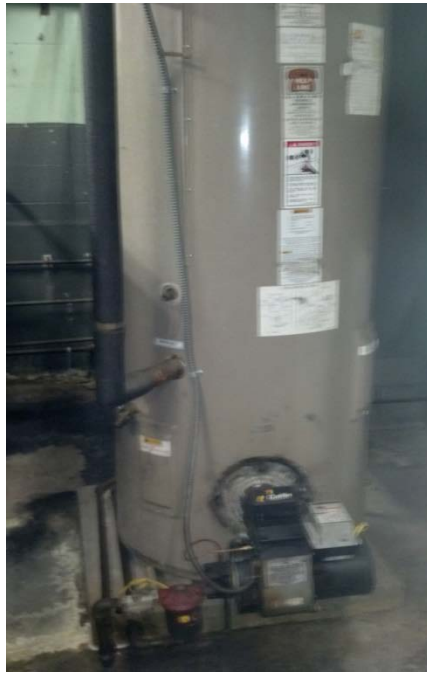
1. Domestic Hot Water System: The Schools domestic hot water is generated by an oil-fired water heater. The water heater is as manufactured by AO Smith, Model COF-199-934, rated 199,000 BTU/HR output. This water heater was installed in 2004. The existing domestic hot water system also incorporates a re-circulating pump, isolation valves and a thermostatic mixing valve. Hot water storage temperature is approximately 140 deg. F. A 140 deg. F. hot water loop is provided to serve the kitchen fixtures and does not incorporate a thermostatic mixing valve. A 110 deg. F. hot water loop serves all other plumbing fixtures throughout the building and incorporates a thermostatic mixing valve. The existing domestic hot water system is in good condition.

Existing Oil Fired Water Heater

- Provide isolation valves on the hot and cold water distribution system.
- Provide full sprinkler coverage throughout the building.
- Replace existing water closets with high efficiency, low flow, 1.28 Gallons Per Flush (GPF) water closets.
- Replace existing urinals with high efficiency, low flow, .125 GPF urinals.
- Replace lavatory faucets with low flow .5 GPM faucets.
- Provide emergency generator.
- Replace gasket on existing grease interceptor.
- Develop a plan for replacement of the chiller and associated pumps, the air handling units and associated exhaust fans, and the boilers as this equipment will likely require replacement in the next five (5) to ten (10) years.

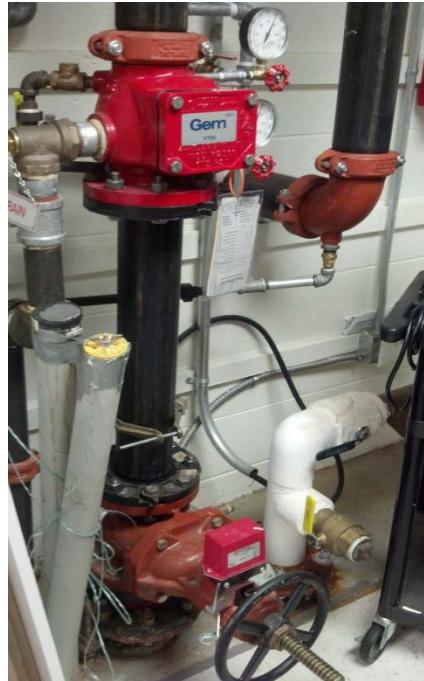
1. The building is currently served by a 6-inch fire protection service and enters the building at the northeast side of the building. The service equipment located within the building incorporates a single alarm valve riser, monitored isolation valve, gauges, bells and drains. The 6-inch main is supplied by a 36,000 gallon on site water storage tank and electric fire pump located within a buried vault. The service equipment located within the vault consists of a 750 GPM, 180psi, 120 HP electric fire pump, jockey pump, controllers, auto transfer switch, test loop, fire department connection, isolation valves, tamper switches and pressure regulating valve. The existing equipment is in fair condition.

Existing Fire Service Riser

3. The existing wet pipe fire protection sprinkler system consists of the following:
 - Upright sprinklers with wire guards in Storage Rooms, Boiler Room and Janitor's Closets.
 - Sprinklers are 1/2" orifice, 165 degree F temperature rating, 5.6 K-factor.
 - High temperature sprinklers are installed in the Boiler Room.
4. The existing sprinkler equipment is in good condition. A full NFPA 13 sprinkler system should be installed throughout the entire building.

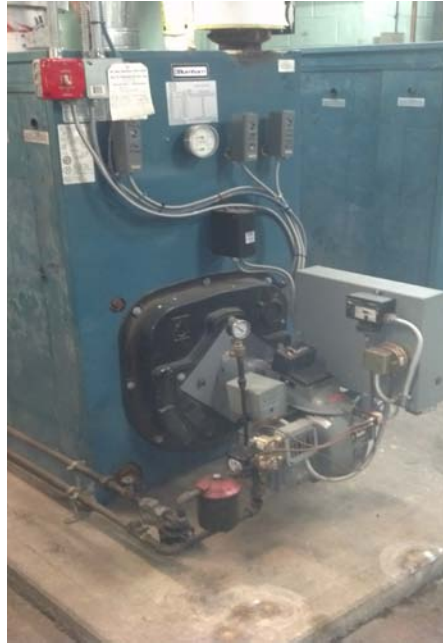
1. The building is served by (2) Burnham oil fired hot water boilers that were installed during the most recent renovation. This equipment is in good condition.

Existing Boiler

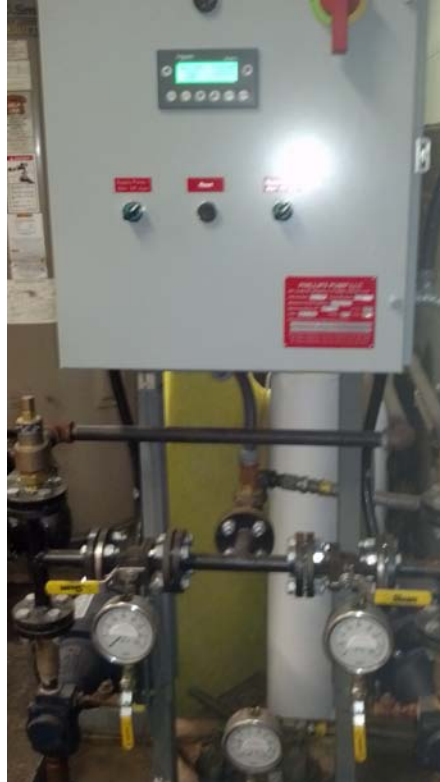
- Fuel oil is stored in a 12,500 gallon underground fuel oil storage tank. Duplex fuel oil transfer pumps are located in the boiler room providing oil to the boilers and the domestic hot water heaters. The entire fuel oil transfer system is provided with a leak detection system. The fuel oil transfer system is approximately two (2) years old and is in very good condition.

Fuel Oil Pumps

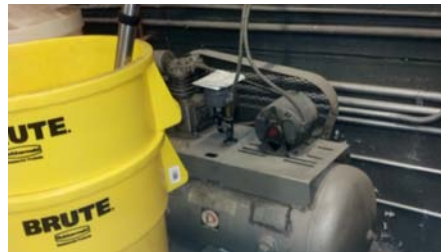
1. The building systems are controlled by a Siemens direct digital control system that is approximately ten (10) years old. This system is in good condition. Region 13 personnel noted that there are currently no issues with the control system.

Control System Compressor

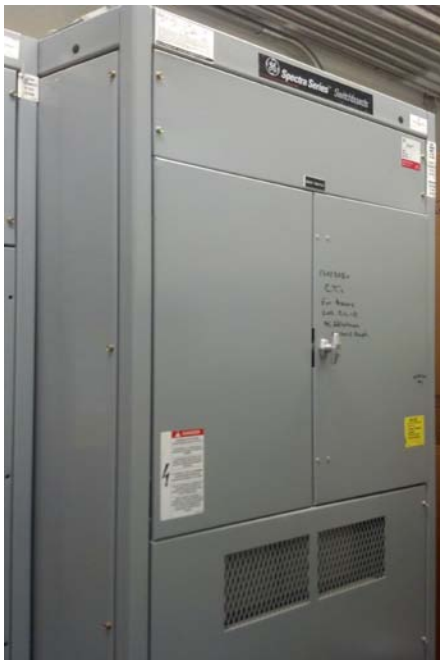
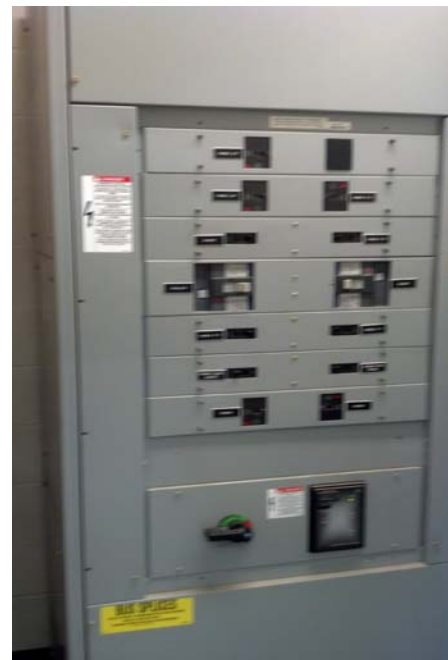
1. The building is served by a 1600A, 208/120V, 3-phase, 4-wire, main electrical service with circuit breaker distribution, CT compartment and integral TVSS. The main switchboard is located in the Main Electrical Room. This equipment is (10) years old and in good condition.

Main Electrical Switchgear

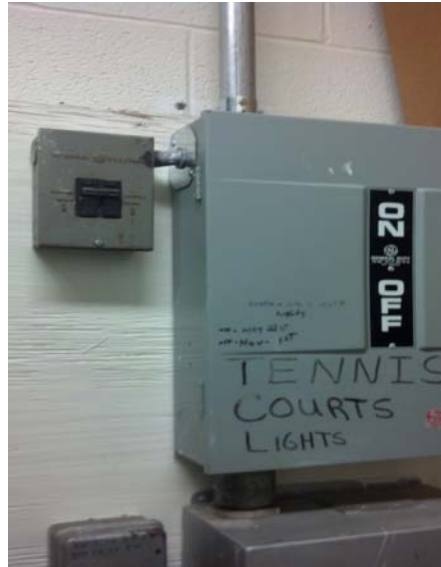
2. The primary electrical service is fed from a pad mounted utility company transformer located behind the school.
3. The adjacent tennis courts are powered from this facility.

Tennis Court Disconnect Switch

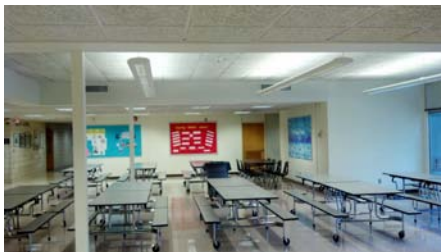
6. Lighting throughout the facility consists of a number of type of light fixtures including surface mounted 2x2 acrylic lensed fixtures, recessed acrylic lensed fixtures, recessed parabolic fixtures, fluorescent hi-bay fluorescent fixtures in the Gymnasium, and pendant mounted fixtures, etc. All of these fixtures are in good condition, however, new higher efficient types of technology such as LED lighting is now available which should be considered for replacement of existing fixtures to reduce energy consumption.

Pendant Lighting

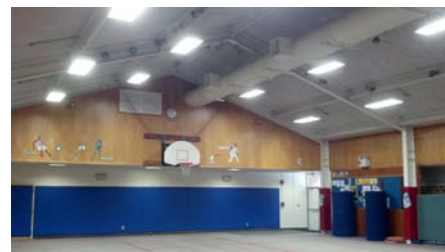
Gymnasium Lighting

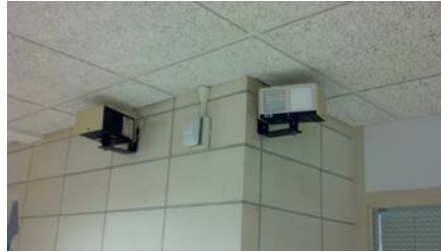
7. Motion detectors have been installed in most of the areas in the building. This equipment is in good working condition.

Typical Motion Detectors

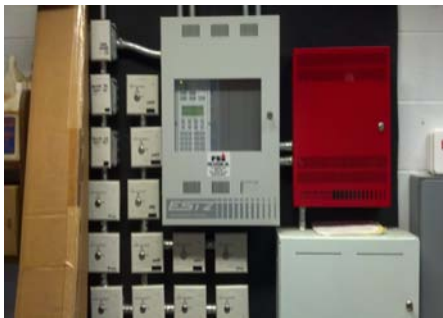
8. The fire alarm system consists of an Edwards EST-2 fire alarm control panel, remote annunciator, and manual fire alarm pull stations and horn strobes, some smoke detectors, and duct smoke detectors. The fire alarm control panel and other peripheral devices are in good condition.

Fire Alarm Control Panel

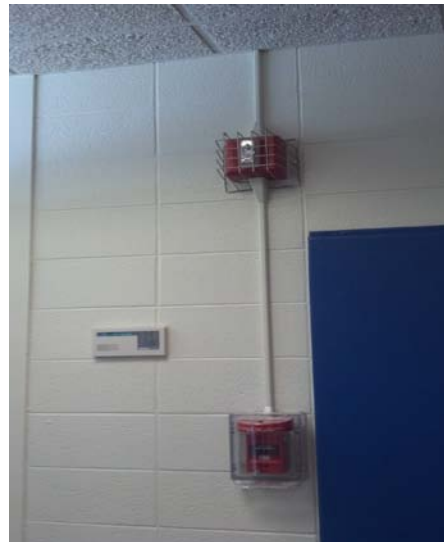
Typical Fire Alarm Pull Station and
Audio-Visual Device

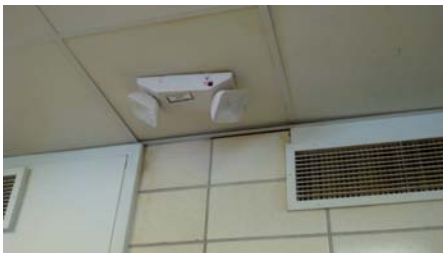
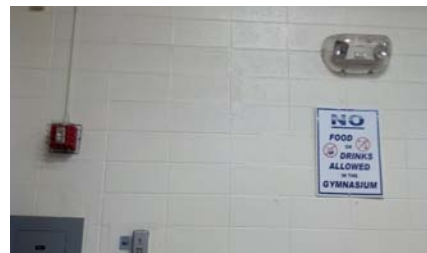
9. The exit signs throughout the building are plastic fluorescent type with integral batteries. These units are in good condition.
10. The emergency lighting in the building consists of self-contained two-head emergency battery units and of using the light fixtures in the specific area fed from the emergency generator as emergency lighting. This equipment is (10) years old and in good condition.

Typ. Emergency Lighting Fixture
